UNITED STATES ENVIRONMENTAL PROTECTION AGENCY

MEMORANDUM

SUBJECT: ON-SCENE COORDINATOR'S REPORT - Removal Action at the Columbus Auto Parts Site, Columbus, Franklin County, Ohio (Site ID #XR)

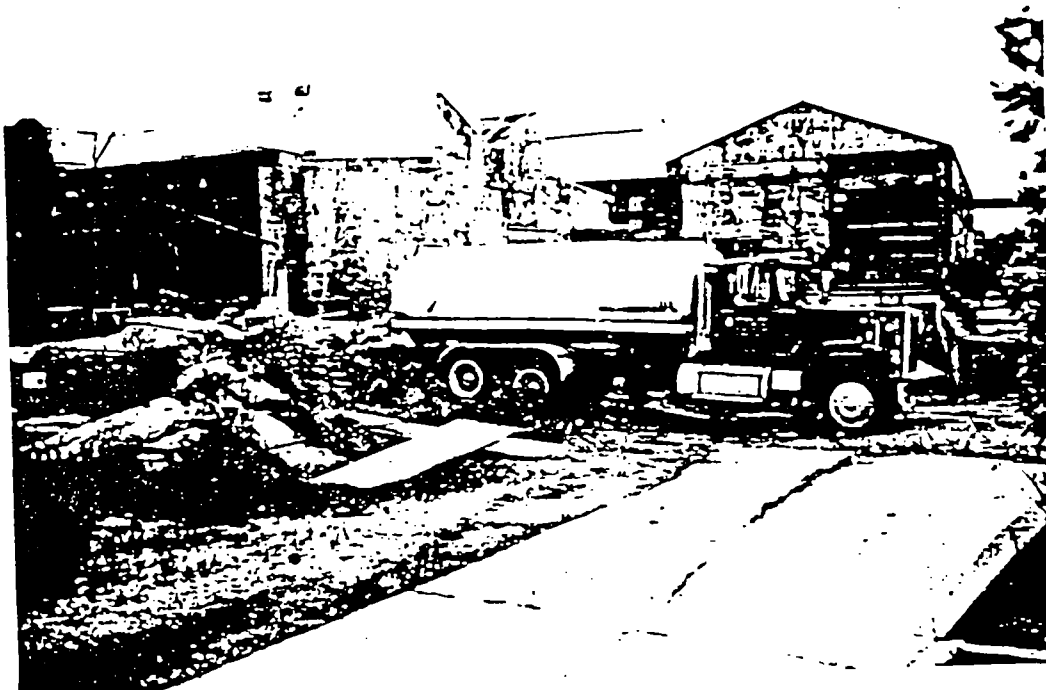
SITE: Columbus Auto Parts TDD: S05-9601-041 PAN: 6J4101RAAO PHOTO: 29
 DIRECTION: Northeast DATE: 10/26/94 PHOTOGRAPHER: Spangler
 DESCRIPTION: Waste diesel fuel being pumped out of USTs 2 and 3 for disposal.

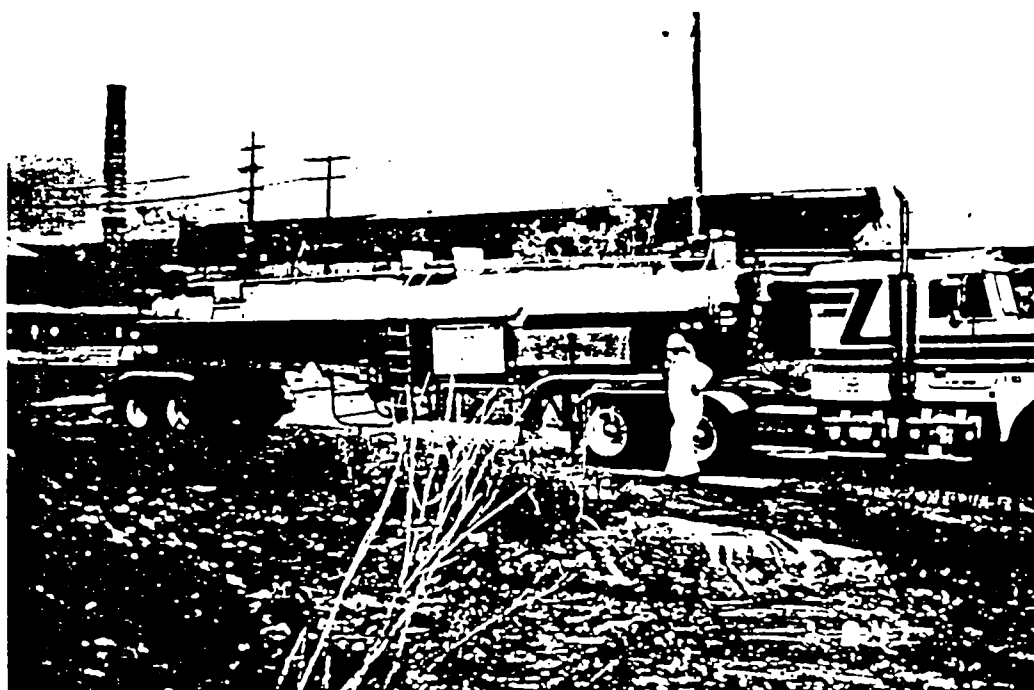
SITE: Columbus Auto Parts TDD: S05-9601-041 PAN: 6J4101RAAO PHOTO: 30
 DIRECTION: Southeast DATE: 11/01/94 PHOTOGRAPHER: Spangler
 DESCRIPTION: Waste cutting oil being pumped out of USTs 4 and 5 for disposal.

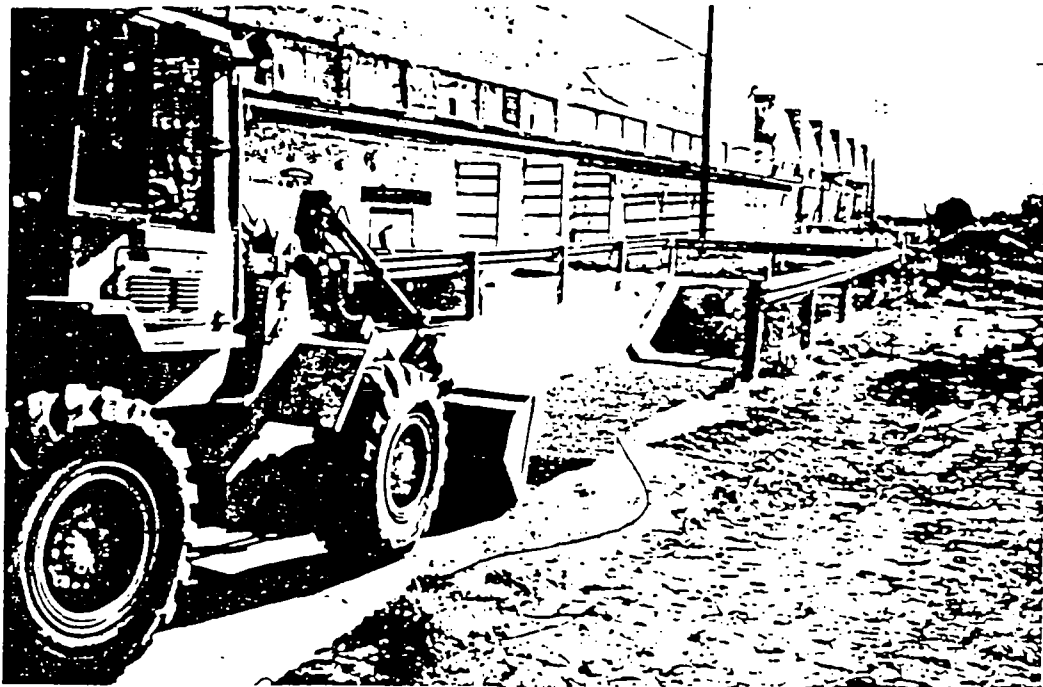
SITE: Columbus Auto Parts TDD: S05-9601-041 PAN: 6J4101RAAO PHOTO: 4
 DIRECTION: Southeast DATE: 12/01/94 PHOTOGRAPHER: Spangler
 DESCRIPTION: ERCS personnel placing the first layer of gravel into the north loading dock after cleaning and removing all wastes.

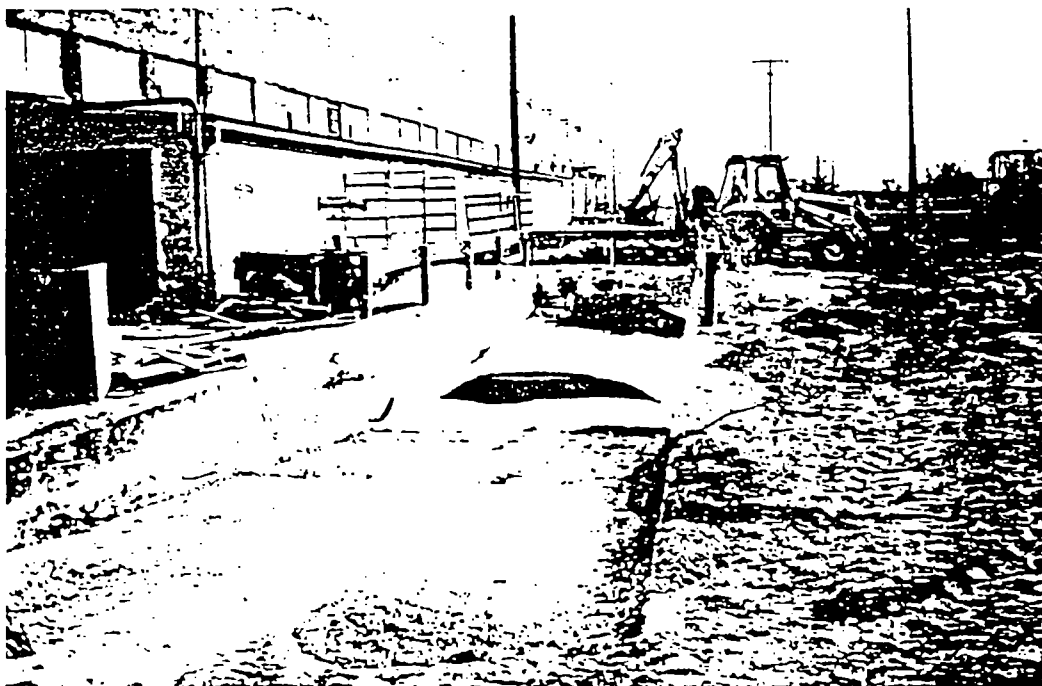
SITE: Columbus Auto Parts TDD: S05-9601-041 PAN: 6J4101RAAO PHOTO: 4
 DIRECTION: South DATE: 12/01/94 PHOTOGRAPHER: Spangler
 DESCRIPTION: ERCS personnel placing gravel on top of the layer of sorbent pad in the north loading dock.

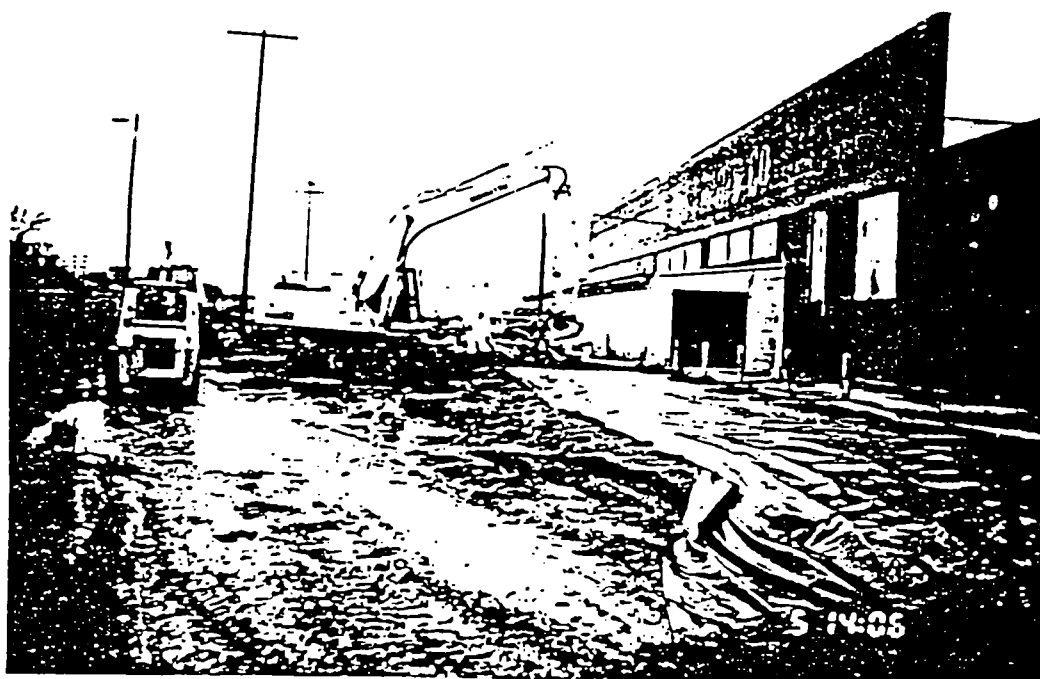
SITE: Columbus Auto Parts TDD: S05-9601-041 PAN: 6J4101RAAO PHOTO: 44
 DIRECTION: Northeast DATE: 12/05/94 PHOTOGRAPHER: Spangler
 DESCRIPTION: ERCS personnel placing sand layer on top of Visqueen
 layer in the south loading dock.

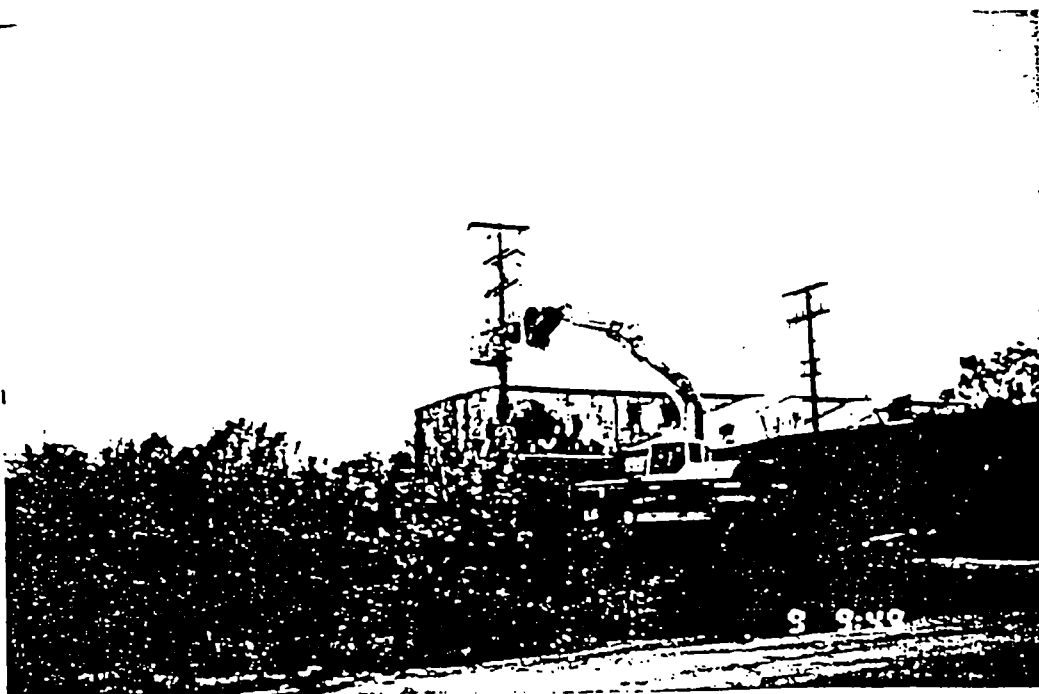
TE: Columbus Auto Parts TDD: S05-9601-041 PAN: 6J4101RAAO PHOTO: 48
 RECTION: Northwest DATE: 11/09/94 PHOTOGRAPHER: Spangler
 DESCRIPTION: ERCS personnel removing PCB transformer.
